# **ENVIRONMENTAL BASELINE SURVEY**

**Huisman United States Army  
Reserve Center (OH 066)  
25445 Harvard Road  
Warrensville Heights, Ohio**

**March 31, 2004**

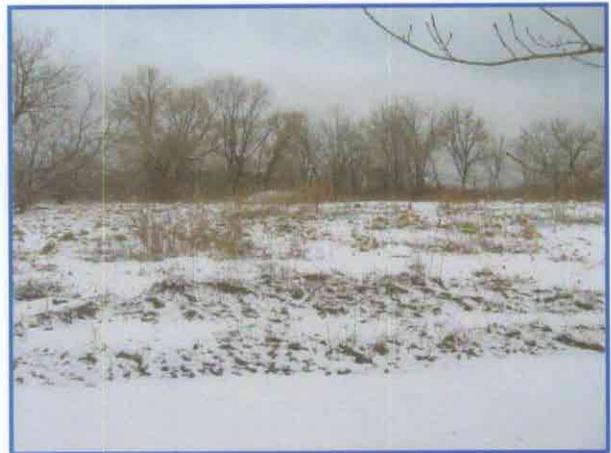
### **North**

Undeveloped commercial land borders the Property to the north. The photograph to the right was taken from the northern portion of the MEP, viewing north.

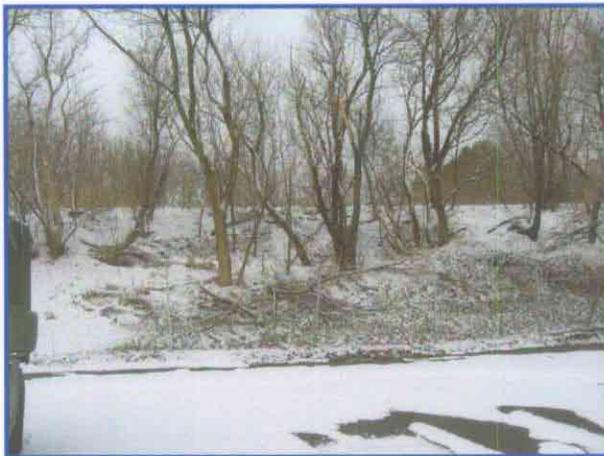
## East

Undeveloped commercial land borders the Property to the east. The photograph to the left was taken from the east side of the OMS, viewing east. Further east is I-271.
